Water Quality in Central Oregon

Eric Nigg

Eastern Region Water Quality Manager

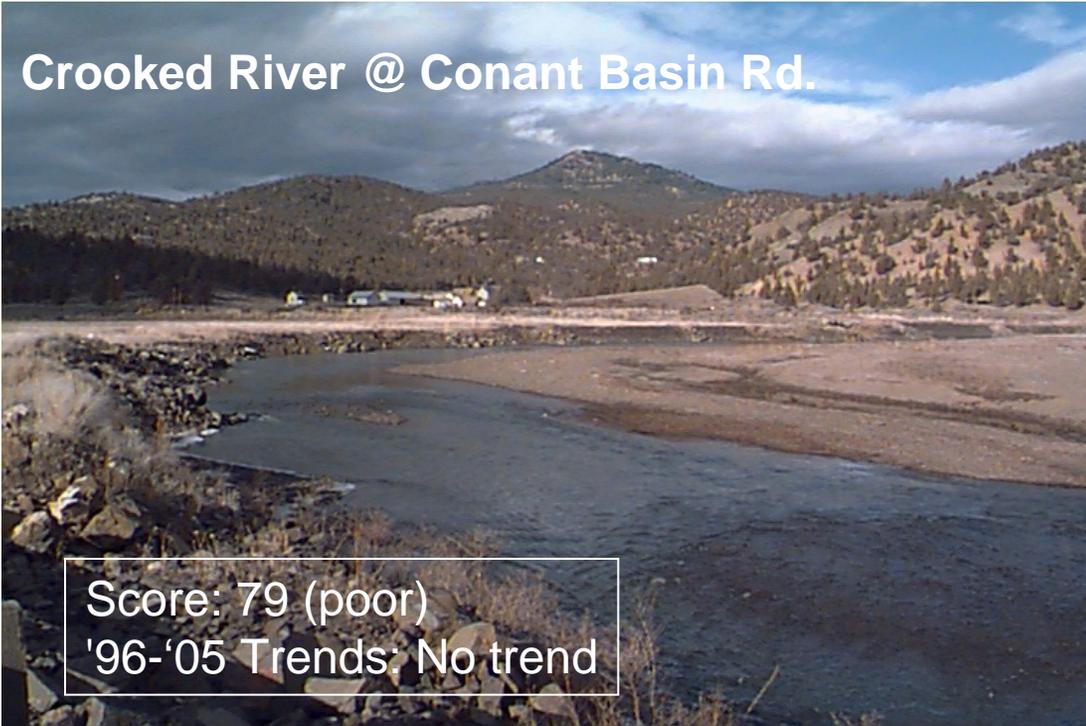
Crooked River @ Conant Basin Rd.

Score: 79 (poor)
'96-'05 Trends: No trend

- **Conant Basin Rd:** *pH standard exceeded year-round, temperature standard exceeded in the summer*
- **Lone Pine Rd:** *elevated bacteria, nitrate & ammonia nitrogen observed; temperature standard exceeded in the summer, pH standard exceeded year-round*
- *Total dissolved gas standard exceeded below Bowman Dam*

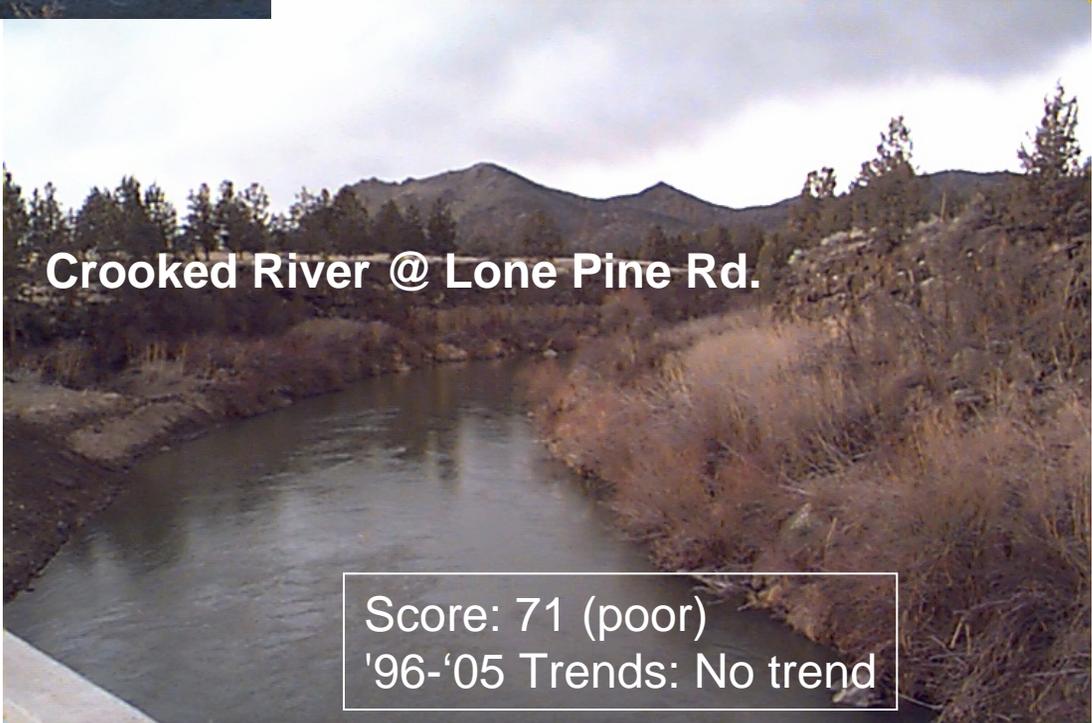
Crooked River @ Lone Pine Rd.

Score: 71 (poor)
'96-'05 Trends: No trend

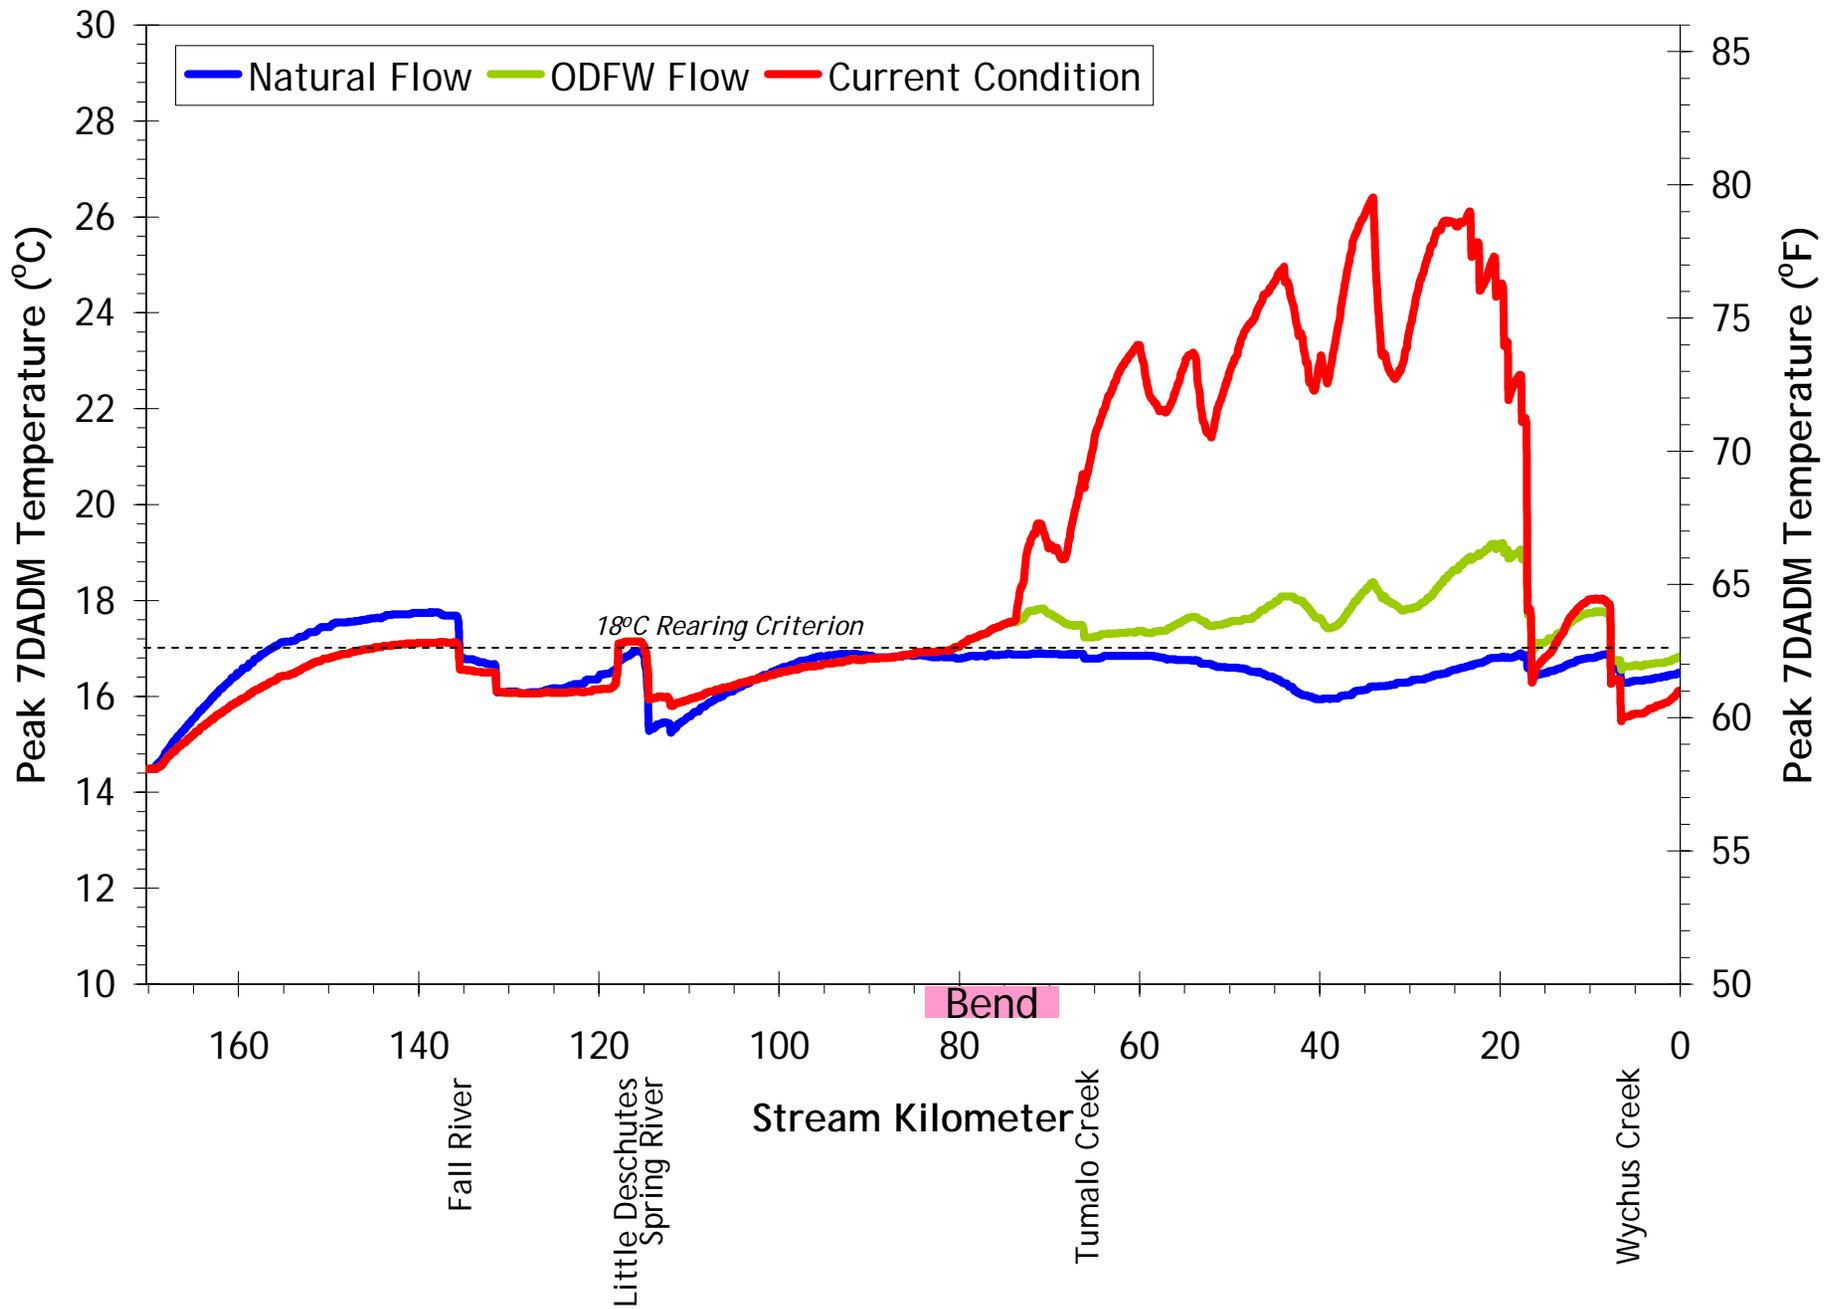
Upper Deschutes River 7DADM

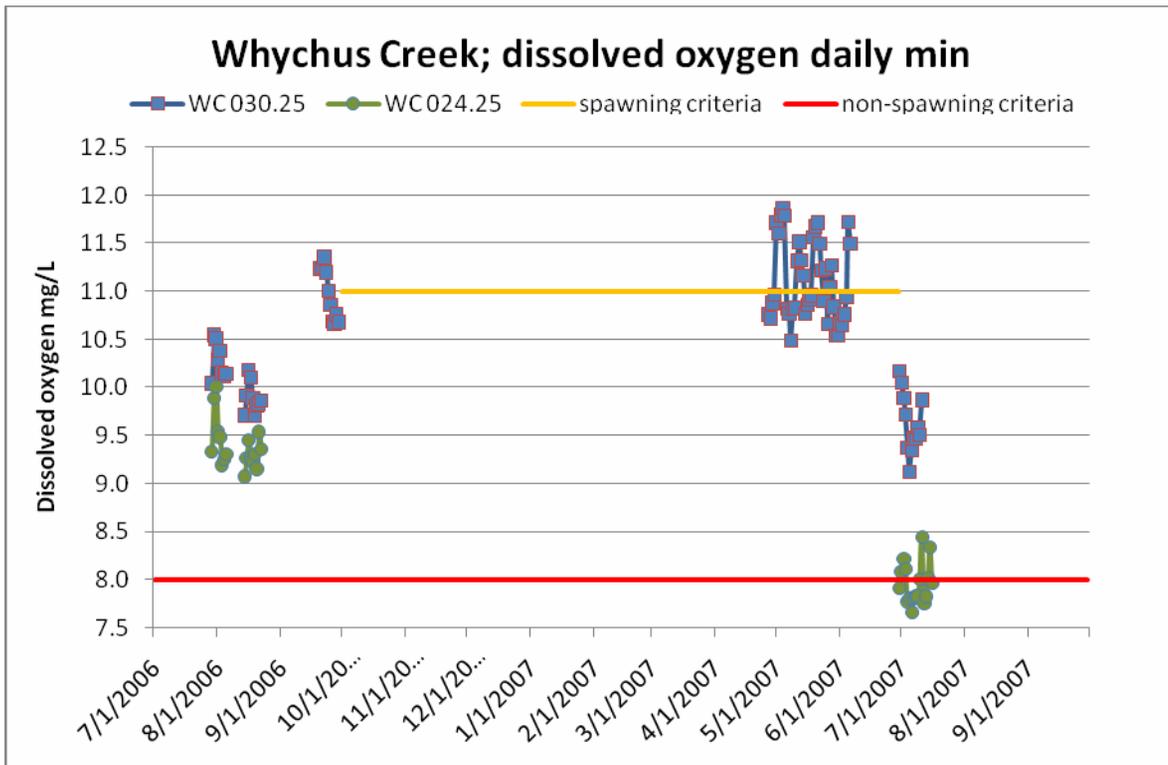
Figure 1. Whychus Creek; daily minimum dissolved oxygen concentrations

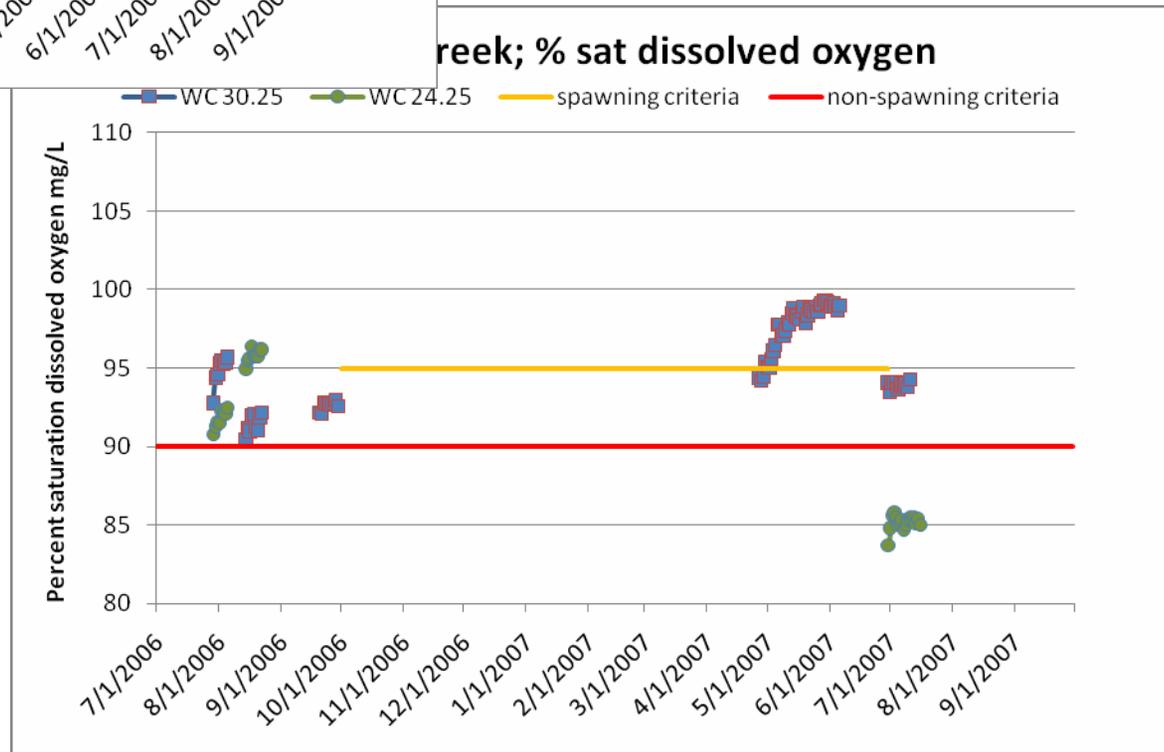
Figure 2. Whychus Creek; daily minimum percent saturation of dissolved oxygen
